Case Study

The impact of changes in the geological conditions of road bedrock layers while the road was in use

DOI 10.2478/otmcj-2019-0008

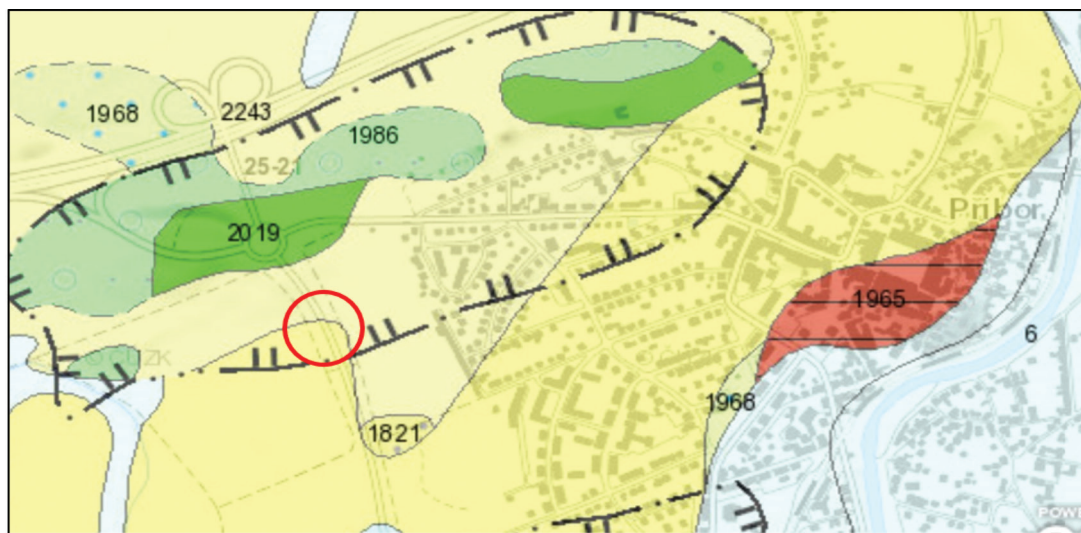
Fig. 2: Area according to the geological map [explanation of geological structures (the structures themselves relate only to the bold geological structure) is as follows: 19 light yellow-loess clay, genesis-eolic sediment, system-Bohemian Massif-covering formations, formation-quaternary, era-kenozoic, Pleistocene department; 2,243 ocher to pink-eluvial sediments (weathered mantle) stone-sand-clayey eluvia of sedimentary rocks, system-Carpathians, formation-quaternary to neogene, era-kenozoic, department Pleistocene; 1,821 ocher-yellow-marinated sediments, calcareous clay (tég), in places with sand system-Carpathian Foredeep, formation-neogene, era-kenozoic, department-miocene, grade-Baden; 2,019 green-volcanites, cucumber, picrit, tuff, tuffite, system-Carpathians, area-flysch zone, region-outer group of nappes, regional unit-Silesian, formation-chalk, era-mesozoic, department-lower chalk, degree-berrias, Valangin, Hauteriv, Barrem, Apt, Formation-Volcanities of the Ashtree Association; 1,986 bluish-marinated, sandstone, conglomerate, claystone, limestone, system-Carpathians, area-flysch zone, region-outer group of nappes, regional unit-Silesian, formation-chalk, era-mesozoic, department-lower chalk, degree-apt-alb, formation-Tešín-Hradiště; 1,968 grey-yellow with blue dots-marinated, claystone, sandstone, conglomerate, system-Carpathians, area-flysch zone, region-outer group of nappes, regional unit-Ždánice unit, sub-Silesian unit, formation-chalk to paleogene, era-mesozoic to kenozoic, department-Upper Cretaceous to Paleocene, degree-Turon, Coniak, Santon, Campan, Maastricht, Formation-Frýdek].

calic claystone, sandstone and conglomerates of the Ždánice and sub-Silesian unit formed by the Frýdek formation. Map of the plan illustrates the geology clearly and the road that is the subject of the solution (see the red ring in Figure 2). The information obtained from the geological survey shows that the covered formations at the road's location are formed by eolic loess sediments and Quaternary sediments from the topsoil layers of the Chlebovice and Frýdek layers.
